SCUBAPRO® Mark 20 First Stage Piston & HP Seat Components

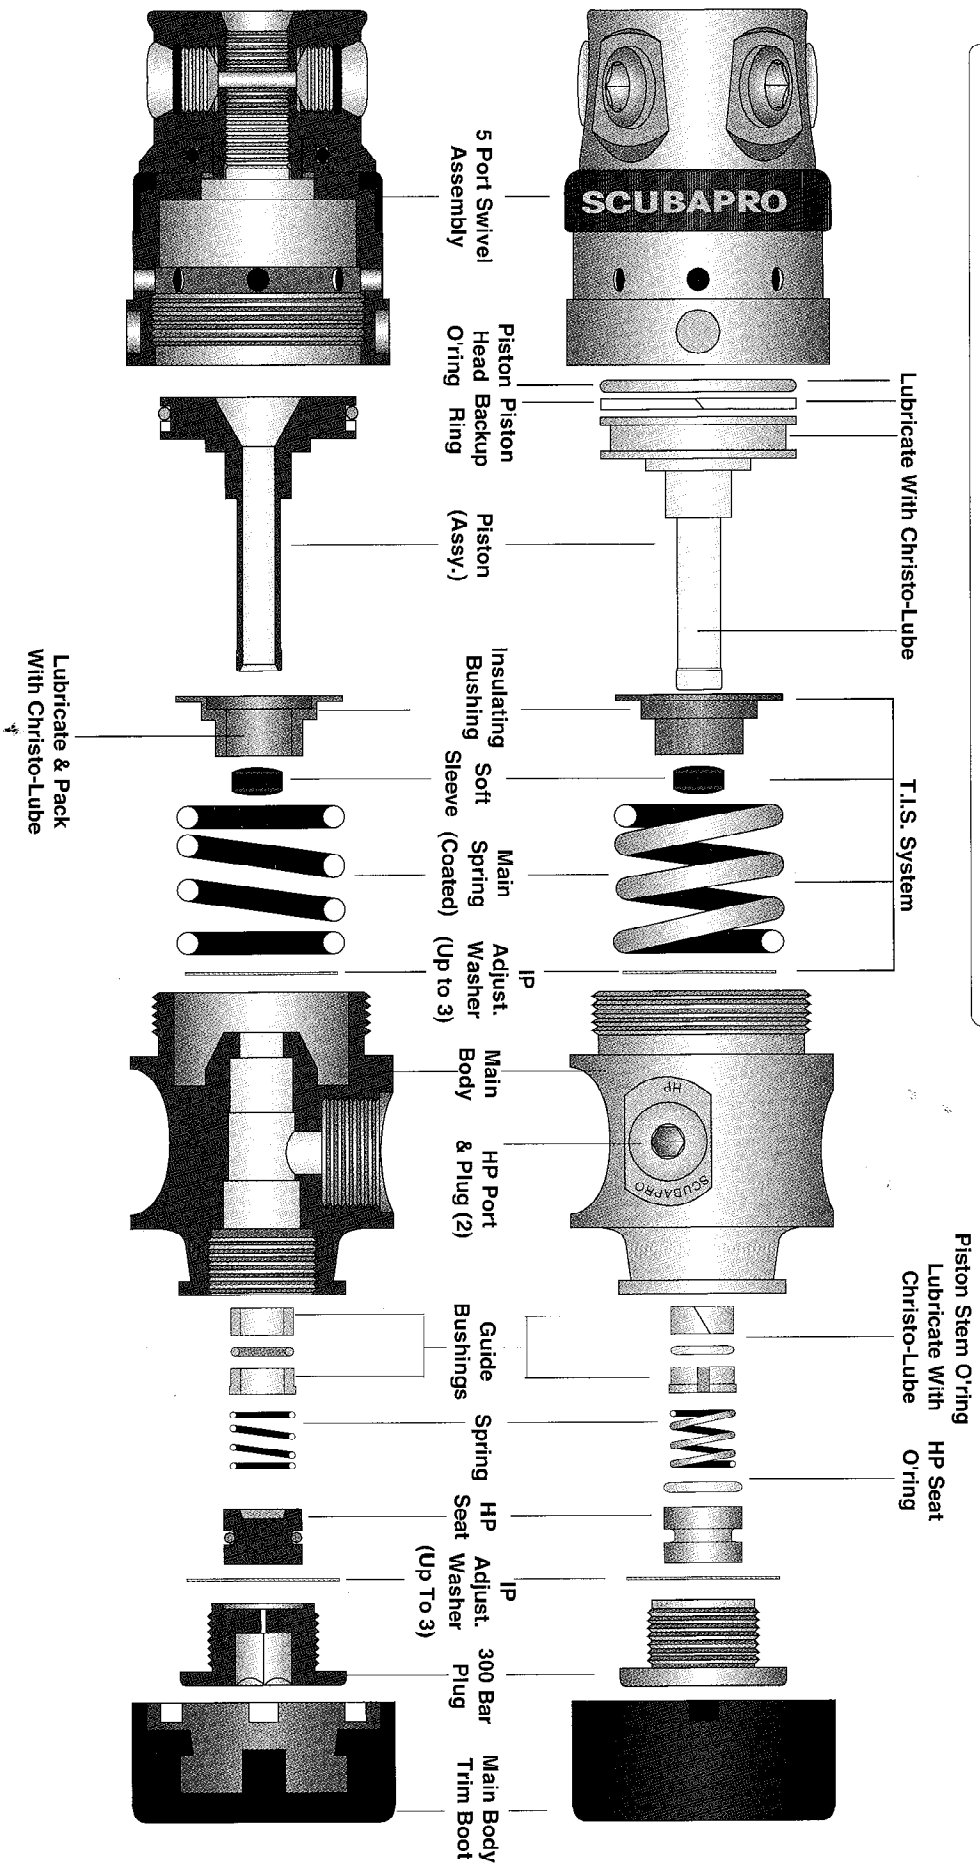
Figure #3

The illustration below shows the piston and high pressure seat components. Both the piston head and piston stem o-rings should be replaced and properly lubricated with Christo-Lube. The HP seat and guide bushings are also replaced during annual service. The Mark 20 bushing system is vital to the high pressure performance. By replacing it at regular intervals, the piston-to-seat alignment is preserved and remains the same as a new first stage.
